Field Notes  
Relative to  
Photographs of  
Flood Damages  
"Otoy Investigation"

Notes on  
Photographs  
of  
Flood Damages  
in  
San Diego County

Damages done in  
January 1916

Photographs taken  
May and June  
1916  
by W.C. Earle

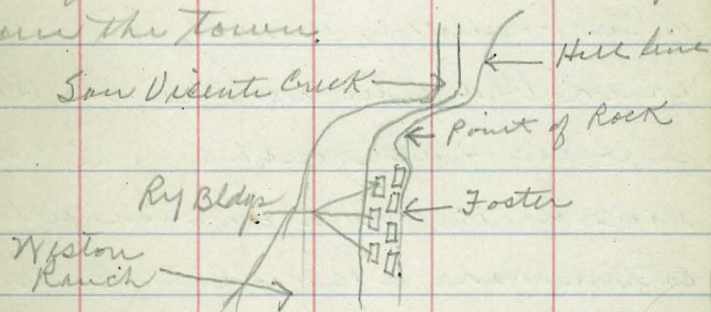
No 1-3 San Diego and South Eastern Ry. Station Bldgs. at Foster. The land in foreground was formerly cultivated but now washed out to gravel bottom. Beyond these buildings and at the base of the hill is the residence of Mr. Joe Foster, supervisor. The hills were washed fairly clean of soil and boulders and the valley land (gardens, yards etc.) are covered with deep deposit of soil and rock. The canyon shown back of the water tank is Messing canyon, water came out of this canyon 30 feet deep. Ranchers in the canyon attempted to warn the people at Foster by phone but could not on account of wires being down

or line washed out. The only thing that saved the town of Foster from probably being entirely washed out was a point of rock that projects into the river just above the Foster residence which is the one furthest north in the town, thereby diverting the force of the flow to the west or away from the town.
