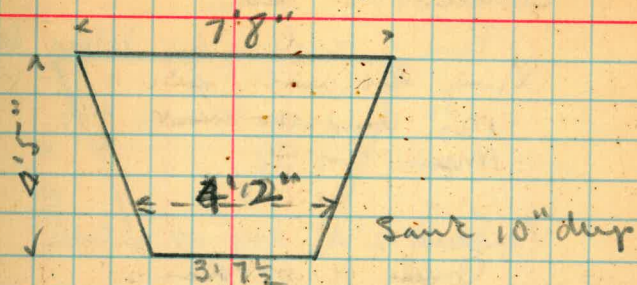
Section of Molony finished ditch  
 above Smiley failure of 1912

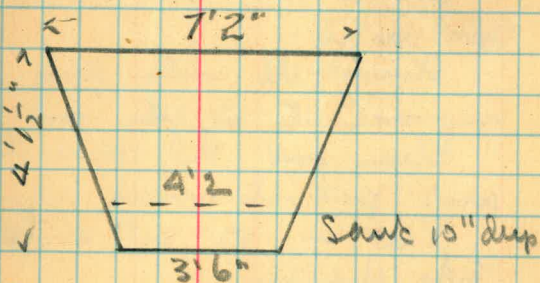
Section of Res finished ditch  
 at rocky point where road descends to  
 creek bottom. (Aug 1912 one)

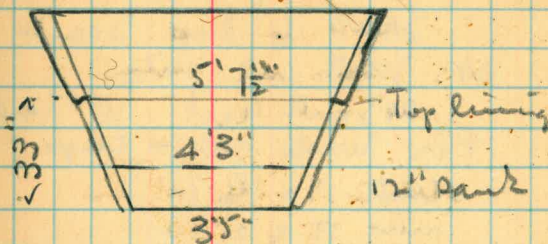
Piece of planting 90' below main  
 ring located 4'  
 12" sand at main ring  
 main ring OK.

Saw 2' 4" deep at intake  
 Intake a problem

Saw outside gate 20" above  
 sand inside.

Questionable whether any temporary  
 improvements at gate would pay  
 clean out the sand chamber  
 and put into working order

Put in 12" sill on lower  
 side chamber.

Repair collapsed section below  
 gate.

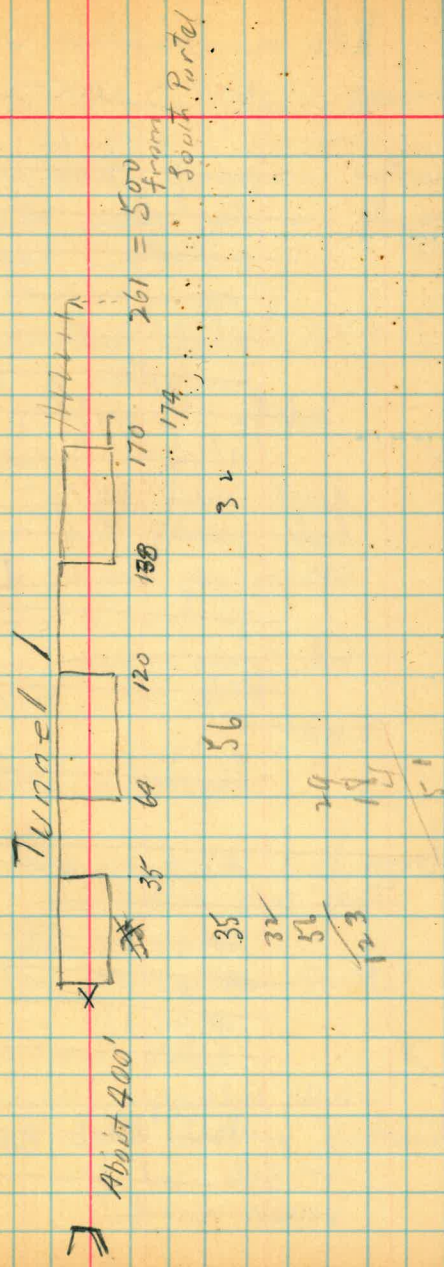
About 400' (see later measurements)  
roof is 15' high and at this point

slabbing should begin. From  
 here to north portal OK  
 —
